Some Test Data on Fireproof Floor Construction

Relating to Cinder Concrete Terra Cotta and Gypsum

A Fire, Load and Water Test Made Upon Cinder Concrete, Terra Cotta and Gypsum Floor Arches

July 29 — Aug. 1, 1913

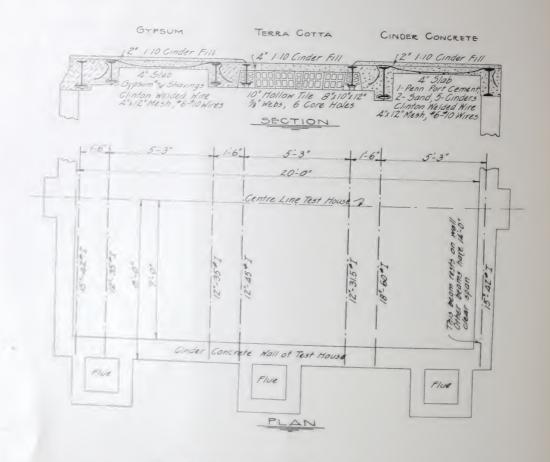
CONSTRUCTION DETAILS OF FLOOR SLABS

It will be noted that the conder concrete slab is practically enterior panel construction, as it is equivaried by one become and on the wall side. The gypsium slab has a two beam support on the cold size with a good and restraint and anchorage for the reinforcement. In this respect the term concerns and the gypsium slab.

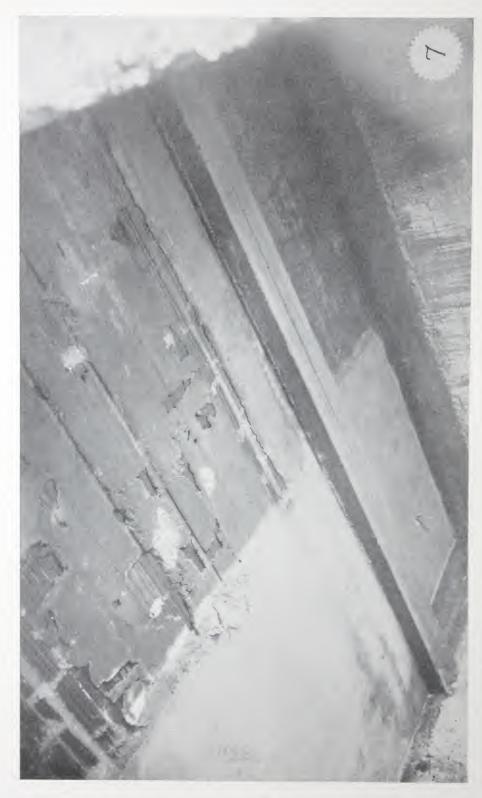
One-half the under surface of each of the first two arches was plastered with two coats, while the gypsum slab was plastered throughout its entire length (Photos 7 and 8).

View taken before the fire, showing mortar joints and impressions of metal camber strips in terra cotta arch. Thermo-couple tubes are shown in each arch and plaster covering on one-half the length of each arch. No. 7. Under Side of Terra Cotta Arch with Cinder Concrete Star in Background

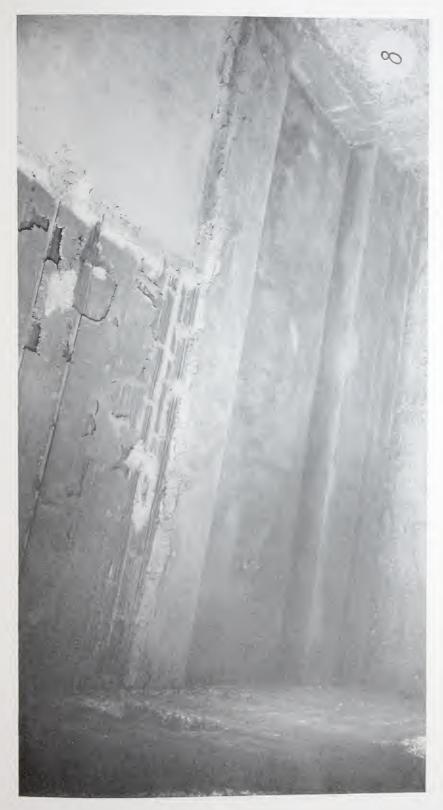
Under Side of Floor with Gypsum Slab in Background, Showing Complete Plaster on this Slab No. 8.

It will be seen from this view and also from Photograph No. 7 that while one-half of the terra cotta and cinder concrete slabs were plastered, the unplastered portion of the terra cotta arch has a very substantial coating of cement mortar. This is mortar which was slushed in under the blocks while the arch was being laid. This mortar was about 12 "thick and, as the photographs show, practically covered all the blocks. This cement mortar no doubt served as a very efficient protection to the blocks against the effect of the fire.

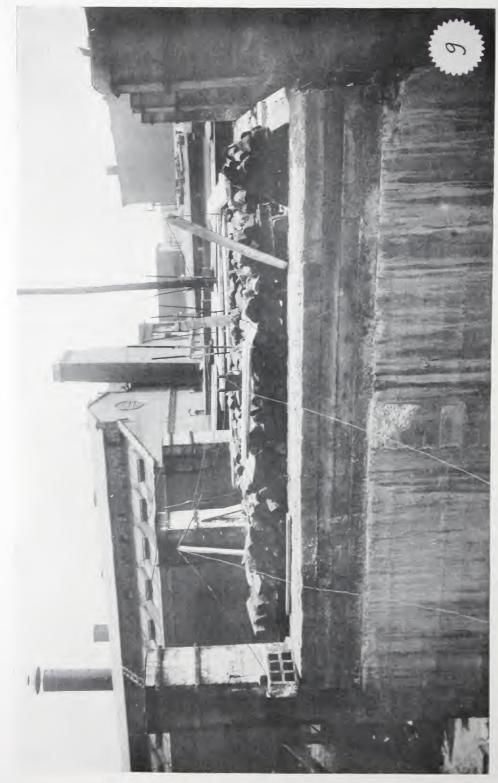
No. 9. Inttal Load of 150 Pounds per Square Foot on Terra Cotta and Cinder Concrete Slabs and 75 Pounds per SQUARE FOOT ON GYPSUM SLAB

This view shows deflection gages and pyrometer leads in place ready for beginning the test.

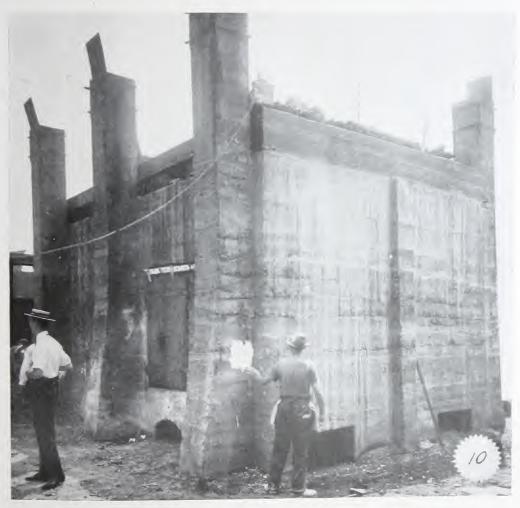
No. 10. VIEW OF TEST HOUSE AT STARTING OF FIRE

The firing was done through the door shown in this view and through a similar opening on the other side of the center fluc. As the fuel was thrown in through these side doors, the tendency was to fire with greater intensity under the outside slabs; that is, the gypsum and the einder concrete slabs. Reference to the log of temperature readings on page 10 will show that the average temperature under the terra cotta arch throughout the test was about 100° less than under the other slabs. The defective pyrometer as there noted eliminated the temperatures under the terra cotta arch for the first thirty-nine minutes of the firing. The average temperature of 1566° therefore represented the average heat after it had reached an intensity of nearly 1300°. If the lower readings represented by the early stages of the firing had been included, this average of 1566° would have been further reduced. The records, therefore, show that the gypsum and einder concrete arches were actually subjected to an average temperature of more than 100° in excess of the temperature under the terra cotta arch.

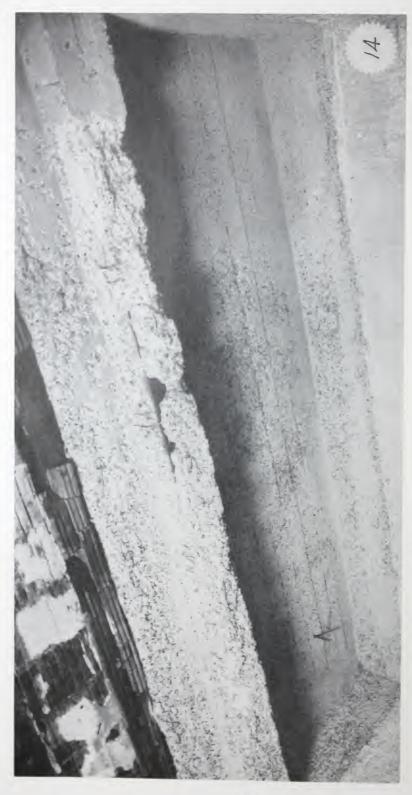
No. 14. Cinder Concrete Slab after Fire and Water

Cinder Concrete. The combined effect of fire and water was to remove the plaster entirely from the slab, leaving the concrete itself in excellent condition. It was only in a region near its center, in order to strike which the stream had to be elevated to nearly a vertical position, and consequently causing maximum punishment that the surface was slightly pitted (Photo 14).

The protection to the deep supporting I-beam naturally suffered more severely. Possibly about 5% of the lower flange was exposed with rather deep-seated cracks running a foot or so in both directions from the stripped portion. The remainder of the protection was deeply scored except for about 18" at the front of the house where the water could not strike it. There it had retained its original sharp edges (Photos 14 and 15). The maximum deflection observed at the center of the slab at end of fire was 3%".

This view shows the removal of all plaster and the slight pitting of the concrete surface. The deep I-beam shown in this view is the IS" I-beam as shown in the details of construction. Owing to the depth of this beam, the lower flange formed a ridge projecting below the under surface of the floor. The concrete protection around this lower flange was, therefore, subjected to the worst possible conditions of fire and water. The slight mutilation of this concrete protection shows how efficiently the concrete and the Clinton Welded Wire beam wrapping withstood the effects of the fire and water.

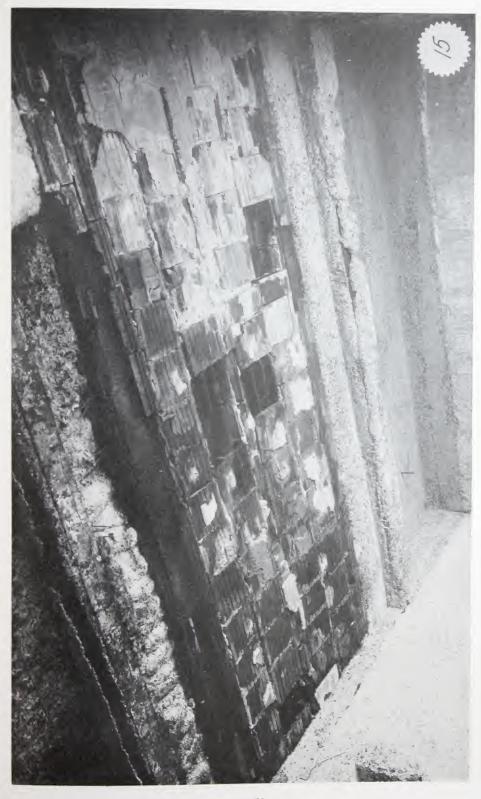
Terra Cotta. About 80% of one beam protection, including many of the bottoms of the skew-backs, 10% of the other beam protection, and the lower faces of six arch blocks were knocked off during fire and water application (Photos 15, 16, and 17).

This view shows an almost complete destruction of the terra cotta beam protection and the destroyed lower webs of a number of the terra cotta blocks in the floor. No. 15. Terra Cotta Arch after Fire and Water

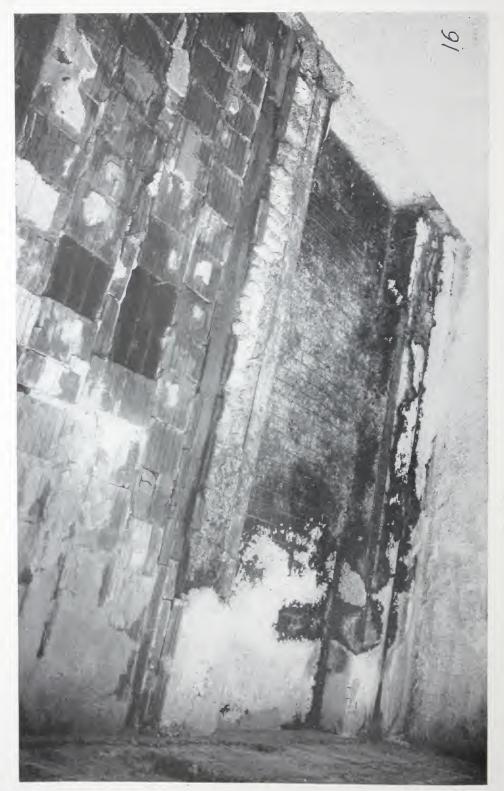
Gypsum. It will be noted on examination of Photo 16 that the protection to the reinforcement and to the supporting I-beam flanges in this bay was entirely removed where the water had full play. Toward the front of the house, where this condition did not obtain, the gypsum covering remained. The material above the wires was softened, deeply scored, and presented a discolored, smoky appearance. Four hours of fire produced a total deflection of only $\frac{1}{16}$ ".

This view shows the removal of practically all material below the reinforcement and the destruction of the lower flange covering of I-beam. No. 16. Gypsum Slab after Fire and Water

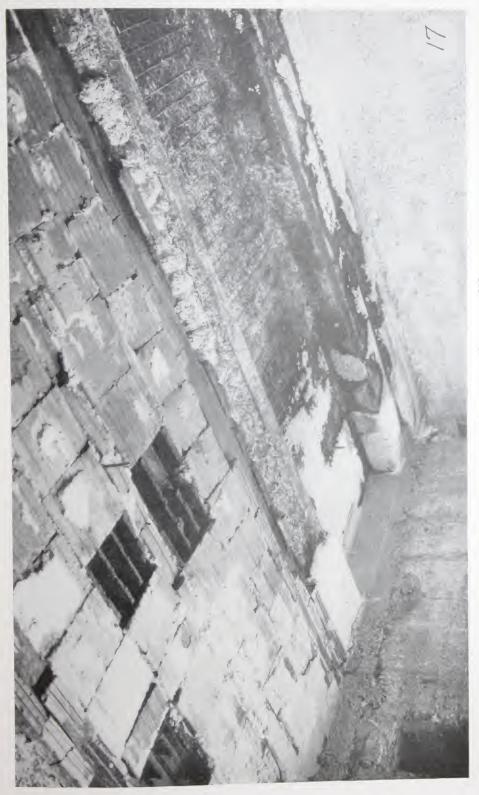
This view shows some protection still adhering to wire near the front wall of test house where water could not strike. No. 17. Gypsum Slab after Fire and Water

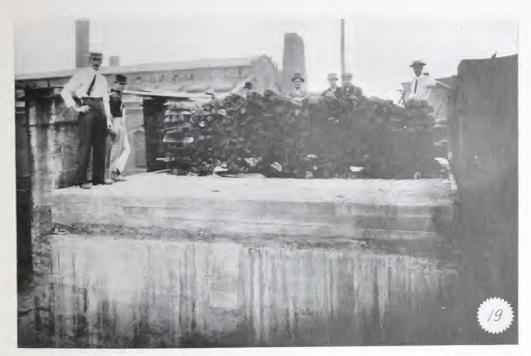
No. 19. Total Load of 600 Pounds per Square Foot on Terra Cotta Arch

A deflection of less than 3/4" was noted in loading the terra cotta arch to this amount. After release of load, the camber of the arch could be plainly seen by sighting along the lower flanges.

After the final load of 600 pounds per square foot was applied, the under surface of the terra cotta slab was carefully examined. More than 75% of the lower webs of the blocks were found to be unsound and portions could be easily removed by hand.

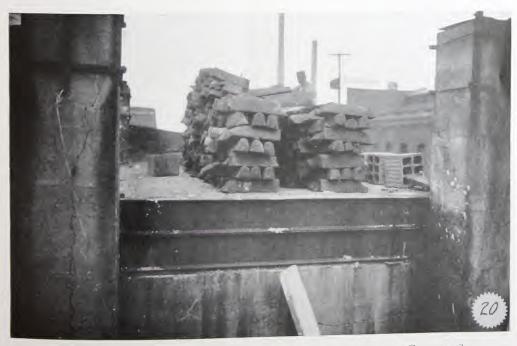
No. 20. Total Load of 496 Pounds per Square Foot on Gypsum Slab

When the load upon the gypsum slabs had been increased to 450 pounds per square foot, the total deflection was 5/8". At 496 pounds per square foot, failure occurred, and the slab was propped from beneath to prevent its total destruction.

August 1, 1913, 36,483 pounds, or 496 pounds per square foot, was placed on gypsum arch and failed. At 400 pounds per square foot arch deflected 5%".

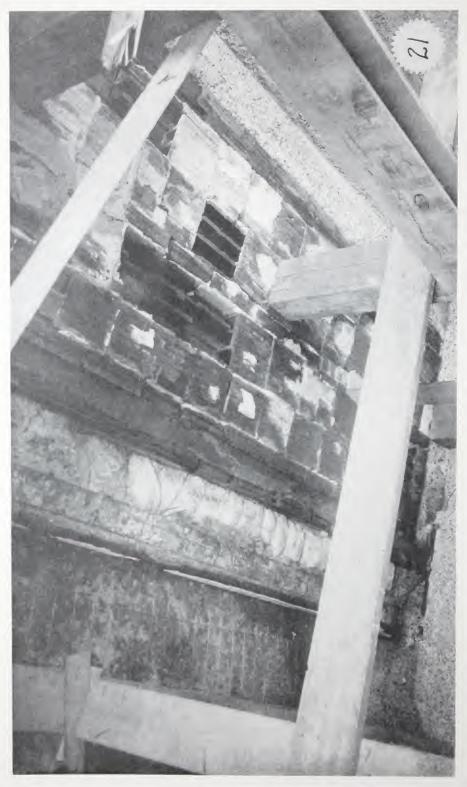
No. 21. Terra Cotta Slab after Load and Sound Test

At completion of load test the under surface of the arch was examined care-It was found that well over 75% of the lower faces were unsound, portions of which could be easily removed by hand. Photo 21 was taken after this examination. Practically the entire load was being carried by the central webs and upper faces of the blocks, many of the lower faces being entirely loose, but keved in by the remaining mortar joints.

The terra cotta arch by tapping bottom face showed that 90% of bottom walls were cracked away from the rest of the block, some being easily removed by hand.

This arch could not be repaired to its original strength.
